Infrared Thermography as a Reliability Tool

9.2.1 PRODUCTIVITY AND QUALITY DEPENDS ON REFRACTORY HEALTH

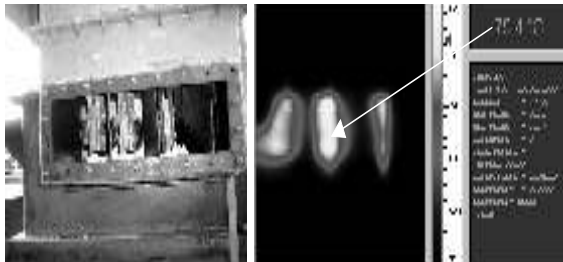
This thermogram shows all the contacts of the transformer as shown to have higher temperature, especially the Y phase. The analysis showed that the problem is not connected to load. It is a local transformer problem. The contacts are to be cleaned and re-tightened. The gas in oil is also high. The transformer oil is to be checked for moisture content and dielectric strength. Condition the oil or change oil as per findings.

If the oil were not taken care of the contacts would again develop higher temperature. So temperature pattern or distribution reveals a lot of

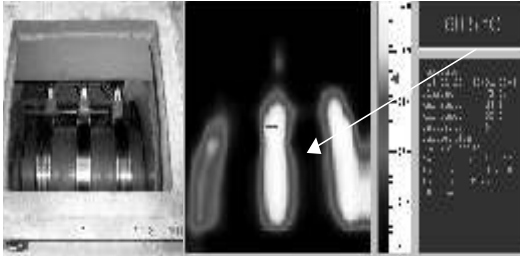
This thermogram was taken to find out the condition of the slip rings. It was found that the R phase (the extreme left hand side contact in the thermogram) slip ring interface shows less temperature than optimum temperature level. It meant that the spring has lost tension. Hence this contact/spring may be replaced at the next opportunity. Had it continued in this manner there would have been a possibility of an early failure. Such failures could be very easily avoided by the use of thermal imaging technique. It is more useful since the technique could be applied online.

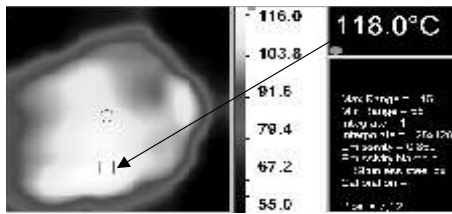
This thermogram shows heat generation at the bottom of an induction motor. And the temperature is quite high for 'B' class insulation. Obviously this motor would fail. However, the thermogram shows a weak insulation at that area. Matters could probably be improved by revarnishing the insulation. It would not have been possible to detect this abnormality so quickly by other means while the motor was running. Thanks to thermal imaging that it also possible to check motors in operation.
