## THERMOGRAPHY REPORT

**MAIN LOCATION:- Ist CIRCUIT CELL HOUSE GROUND FLOOR**

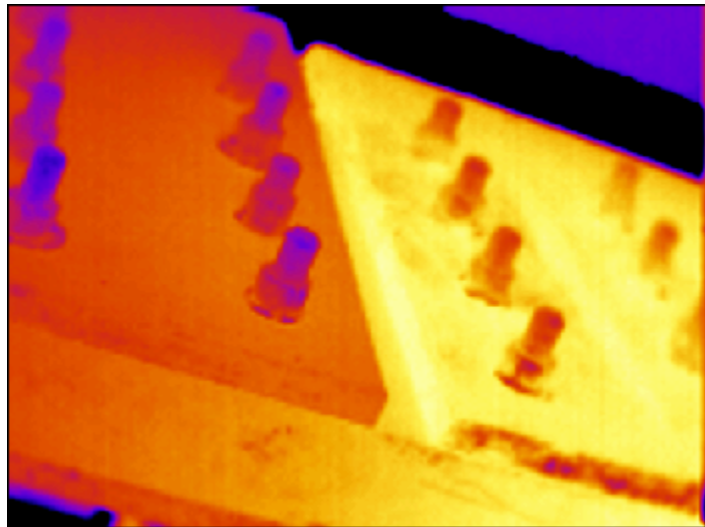
Report No. :- 01

Location	Equipment	Date	Max. Temp.	Min. Temp.	Avg. Temp.	Diff. Tem.
<b>40 B Ist CELL</b>	<b>40 B 8 Main O/G bus bar</b>	<b>24.12.07</b>	<b>85.2</b>	<b>44.9</b>	<b>75.4</b>	<b>40.3</b>

**Basic Observation:- Main O/G bus bar** is over heated.

**Analysis & Recommendation:- Main O/G bus bar** temp. is high it's a semi critical position so close monitoring needed. Should be attended in the next opportunity.

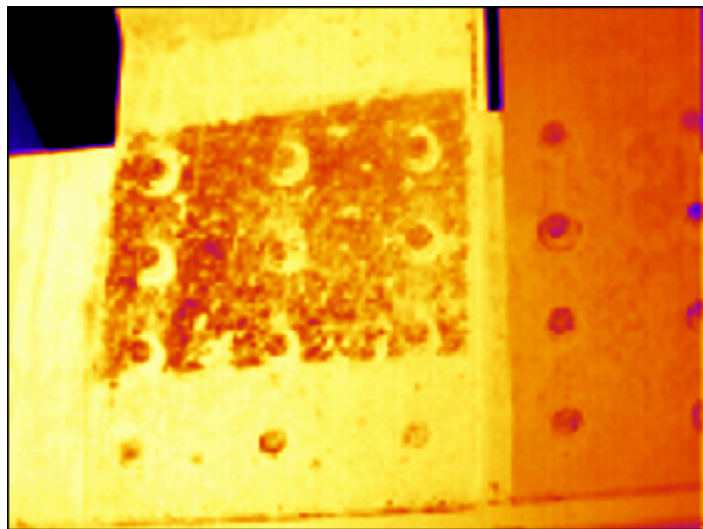
Report No. :- 02

Location	Equipment	Date	Max. Temp.	Min. Temp.	Avg. Temp.	Diff. Tem.
40 B Ist CELL	40 B 8	24.12.07	85.3	39.2	76.0	46.1

**Basic Observation:- Main O/G bus bar 'Z' joint** is over heated.

**Analysis & Recommendation:- Main O/G bus bar 'Z' joint** temp. is high it's a semi critical position so close monitoring needed. Should be attended in the next opportunity.

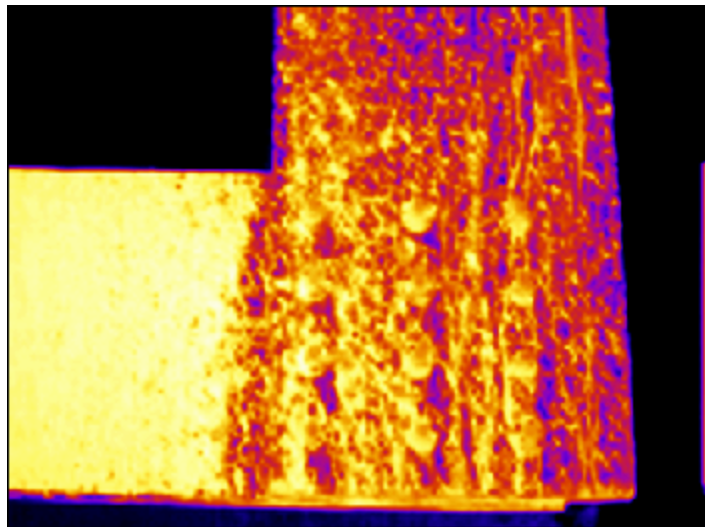
**THERMOGRAPHY REPORT**  
**Report No. :-03**

Location	Equipment	Date	Max. Temp.	Min. Temp.	Avg. Temp.	Diff. Temp.
Ist CELL	31 A1 to 42 A1	24.12.07	84.3	34.5	62.7	49.8

**Basic Observation:- L joint bus bar** is over heated.

**Analysis & Recommendation:- L joint bus bar** temp. is high it's a semi critical position so close monitoring needed. Should be attended in the next opportunity.

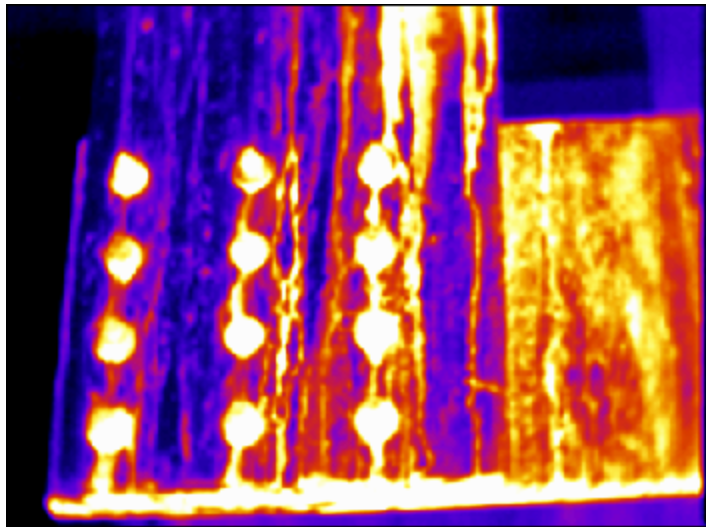
**THERMOGRAPHY REPORT**  
**Report No. :- 04**

Location	Equipment	Date	Max. Temp.	Min. Temp.	Avg. Temp.	Diff. Tem.
Ist CELL	30 B1 to 41 B1	24.12.07	79.5	31.6	48.2	47.9

**Basic Observation:- L joint bus bar** is over heated.

**Analysis & Recommendation:- L joint bus bar** temp. is high it's a semi critical position so close monitoring needed. Should be attended in the next opportunity.

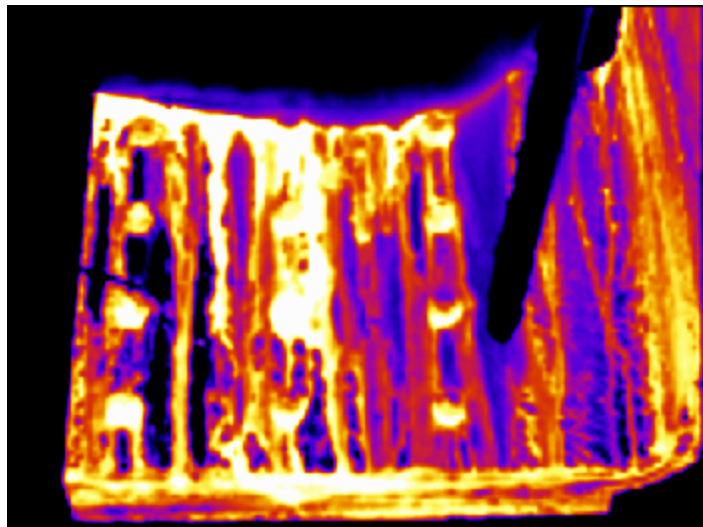
**THERMOGRAPHY REPORT**  
**Report No. :-05**

Location	Equipment	Date	Max. Temp.	Min. Temp.	Avg. Temp.	Diff. Temp.
Ist CELL	30 A1 to 41 A1	24.12.07	79.5	25.4	56.7	54.1

**Basic Observation:- L joint bus bar** is over heated.

**Analysis & Recommendation:- L joint bus bar** temp. is high it's a semi critical position so close monitoring needed. Should be attended in the next opportunity.

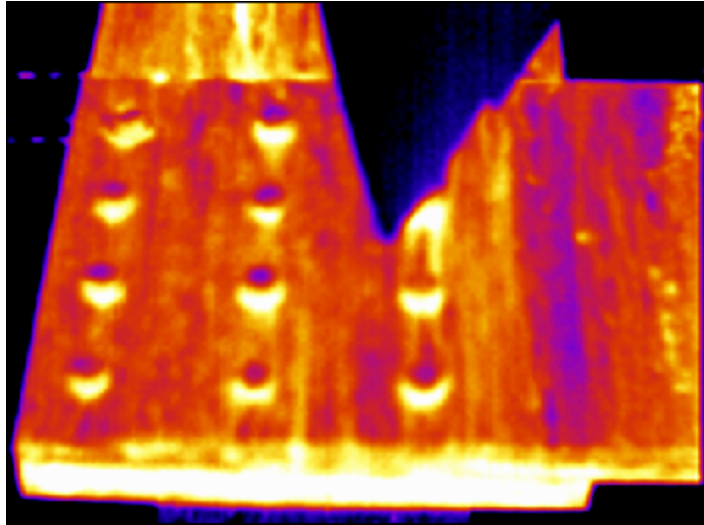
Report No. :- 06

Location	Equipment	Date	Max. Temp.	Min. Temp.	Avg. Temp.	Diff. Tem.
Ist CELL	30 B1 to 41 B1	24.12.07	73.3	35.0	56.9	38.3

**Basic Observation:- L joint bus bar** is over heated.

**Analysis & Recommendation:- L joint bus bar** temp. is high it's a semi critical position so close monitoring needed. Should be attended in the next opportunity.

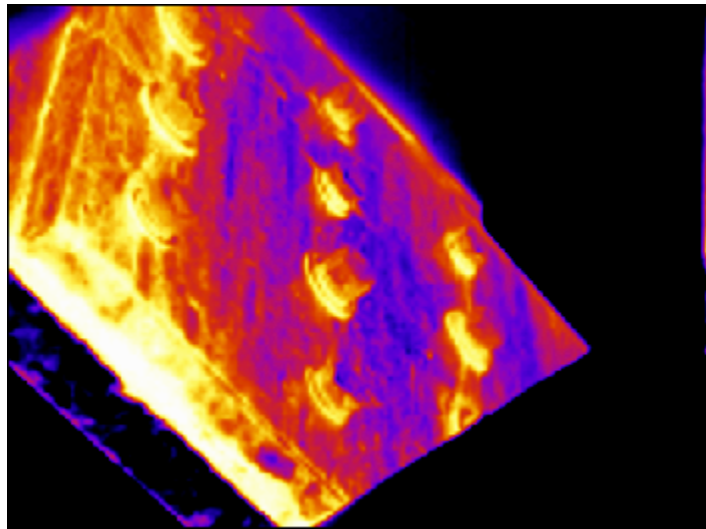
**THERMOGRAPHY REPORT**  
**Report No. :-07**

Location	Equipment	Date	Max. Temp.	Min. Temp.	Avg. Temp.	Diff. Temp
Ist CELL	31 B1 to 42 B1	24.12.07	86.5	36.1	57.7	50.4

**Basic Observation:- L joint bus bar** is over heated.

**Analysis & Recommendation:- L joint bus bar** temp. is high it's a semi critical position so close monitoring needed. Should be attended in the next opportunity.

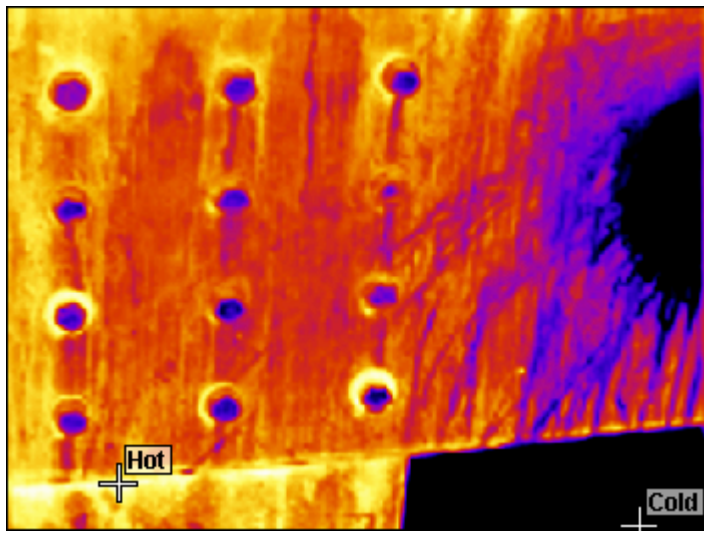
Report No. :- 08

Location	Equipment	Date	Max. Temp.	Min. Temp.	Avg. Temp.	Diff. Tem.
2nd Circuit	30 B8	24.12.07	78.1	42.8	63.9	35.3

**Basic Observation:- Main joint bus bar** is over heated.

**Analysis & Recommendation:- Main joint bus bar** temp. is high it's a semi critical position so close monitoring needed. Should be attended in the next opportunity.

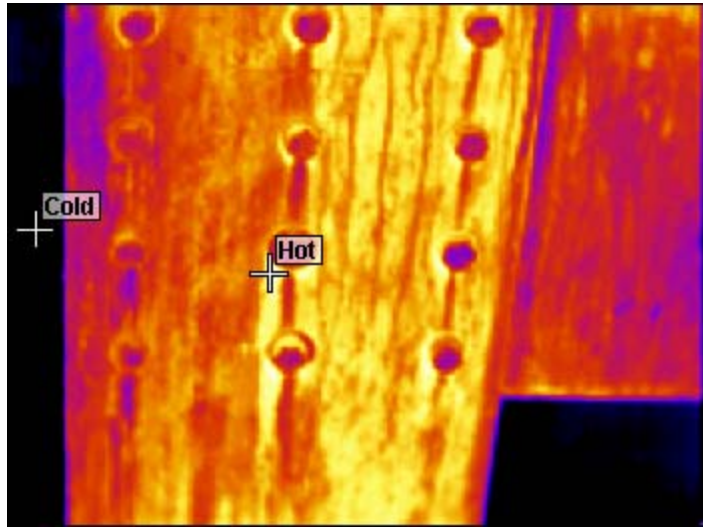
**THERMOGRAPHY REPORT**  
**Report No. :-09**

Location	Equipment	Date	Max. Temp.	Min. Temp.	Avg. Temp.	Diff. Temp.
2nd Circuit	29 B8 Main joint bus bar	24.12.07	74.9	36.1	60.1	38.8

**Basic Observation:- Main joint bus bar** is over heated.

**Analysis & Recommendation:- Main joint bus bar** temp. is high it's a semi critical position so close monitoring needed. Should be attended in the next opportunity.

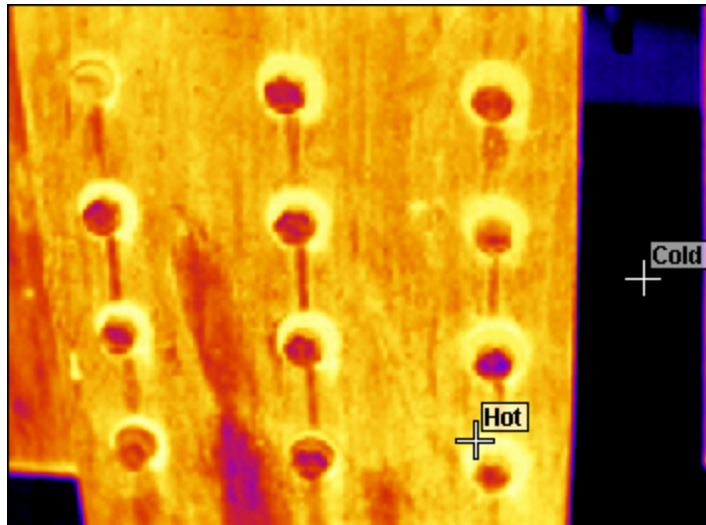
**THERMOGRAPHY REPORT**  
**Report No. :-10**

Location	Equipment	Date	Max. Temp.	Min. Temp.	Avg. Temp.	Diff. Temp.
2nd Circuit	28 A8 Main joint bus bar	24.12.07	76.2	37.1	64.2	39.1

**Basic Observation:- Main joint bus bar** is over heated.

**Analysis & Recommendation:- Main joint bus bar** temp. is high it's a semi critical position so close monitoring needed. Should be attended in the next opportunity.

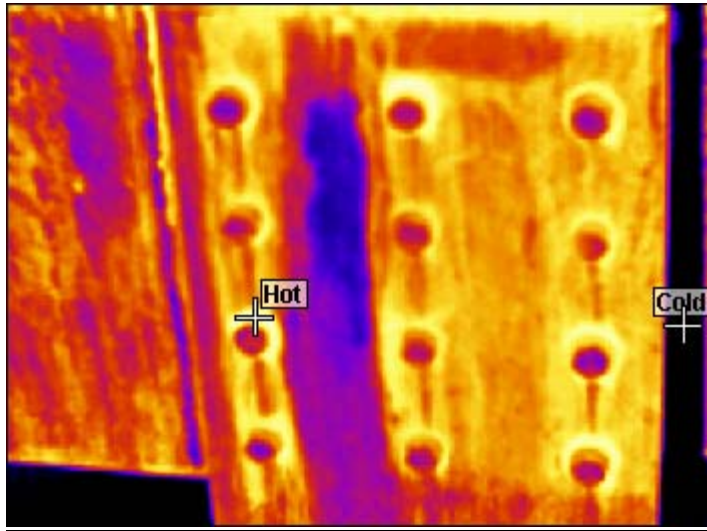
**THERMOGRAPHY REPORT**  
**Report No. :-11**

Location	Equipment	Date	Max. Temp.	Min. Temp.	Avg. Temp.	Diff. Temp.
2nd Circuit	26 A8	24.12.07	80.6	36.1	66.4	44.5

**Basic Observation:- Main joint bus bar** is over heated.

**Analysis & Recommendation:- Main joint bus bar** temp. is high it's a semi critical position so close monitoring needed. Should be attended in the next opportunity.

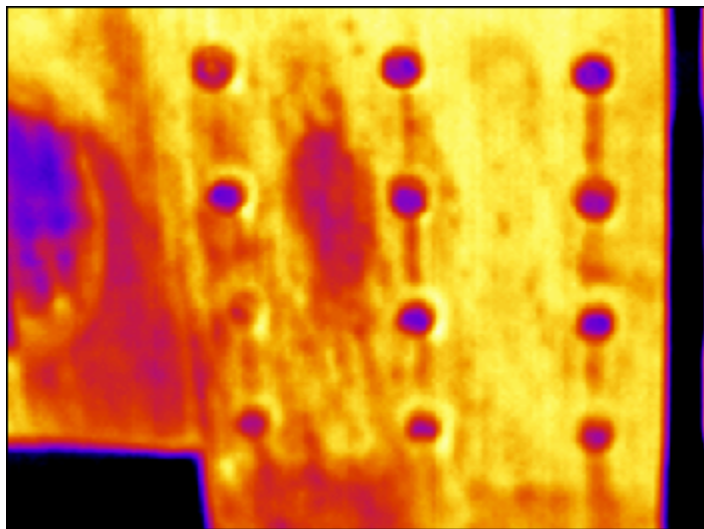
Report No. :- 12

Location	Equipment	Date	Max. Temp.	Min. Temp.	Avg. Temp.	Diff. Tem.
2nd Circuit	24 A8	24.12.07	70.3	37.3	62.1	33.0

**Basic Observation:- Main joint bus bar** is over heated.

**Analysis & Recommendation:- Main joint bus bar** temp. is high it's a semi critical position so close monitoring needed. Should be attended in the next opportunity.

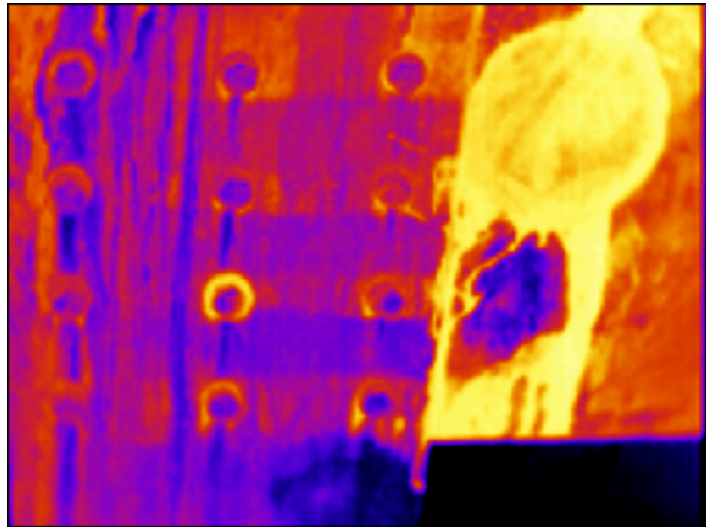
**THERMOGRAPHY REPORT**  
**Report No. :-13**

Location	Equipment	Date	Max. Temp.	Min. Temp.	Avg. Temp.	Diff. Temp.
2nd Circuit	23 B8 Main joint bus bar	24.12.07	75.8	37.3	60.3	38.5

**Basic Observation:- Main joint bus bar** is over heated.

**Analysis & Recommendation:- Main joint bus bar** temp. is high it's a semi critical position so close monitoring needed. Should be attended in the next opportunity.

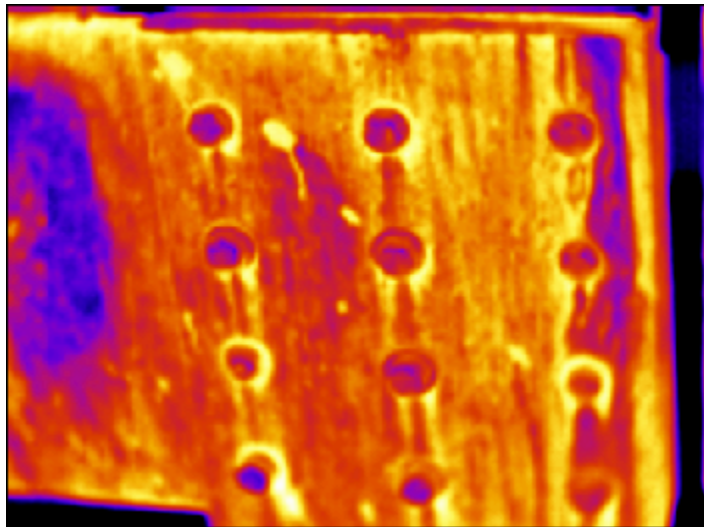
Report No. :- 14

Location	Equipment	Date	Max. Temp.	Min. Temp.	Avg. Temp.	Diff. Tem.
2nd Circuit	22 A8	24.12.07	71.8	39.5	61.0	32.3

**Basic Observation:-** Main joint bus bar is over heated.

**Analysis & Recommendation:-** Main joint bus bar temp. is high it's a semi critical position so close monitoring needed. Should be attended in the next opportunity.

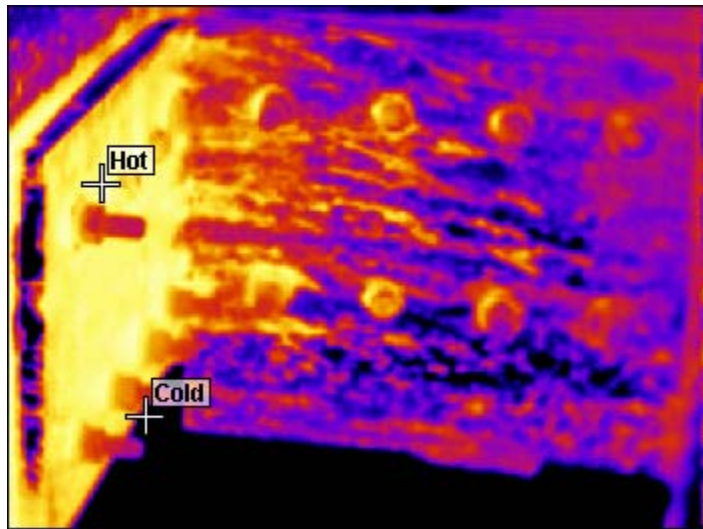
**THERMOGRAPHY REPORT**  
**Report No. :-15**

Location	Equipment	Date	Max. Temp.	Min. Temp.	Avg. Temp.	Diff. Temp.
2nd Circuit	30 B1	24.12.07	86.0	42.4	65.9	43.6

**Basic Observation:-** Main joint bus bar is over heated.

**Analysis & Recommendation:-** Main joint bus bar temp. is high it's a semi critical position so close monitoring needed. Should be attended in the next opportunity.

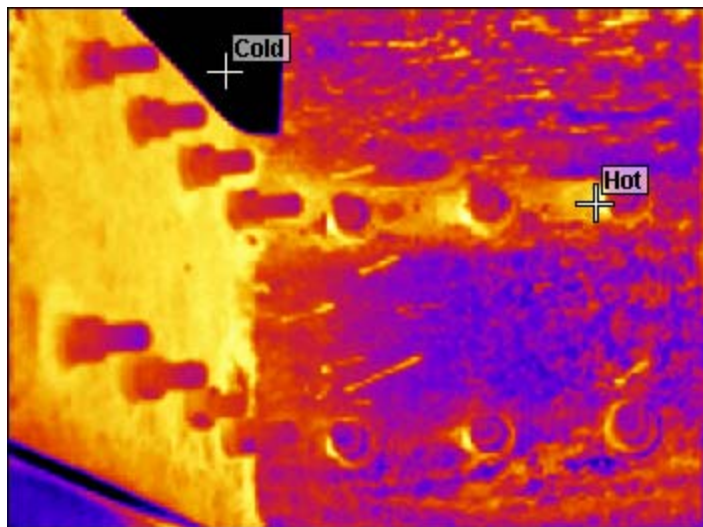
Report No. :- 16

Location	Equipment	Date	Max. Temp.	Min. Temp.	Avg. Temp.	Diff. Tem.
2nd Circuit	27 B1 Main joint bus bar	24.12.07	82.7	36.4	67.7	46.3

**Basic Observation:- Main joint bus bar** is over heated.

**Analysis & Recommendation:- Main joint bus bar** temp. is high it's a semi critical position so close monitoring needed. Should be attended in the next opportunity.
