THERMOGRAPHY REPORT

MAIN LOCATION:- CANPAC DIVISION

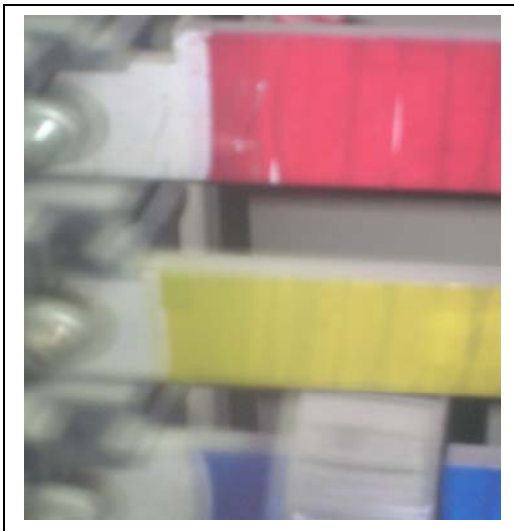
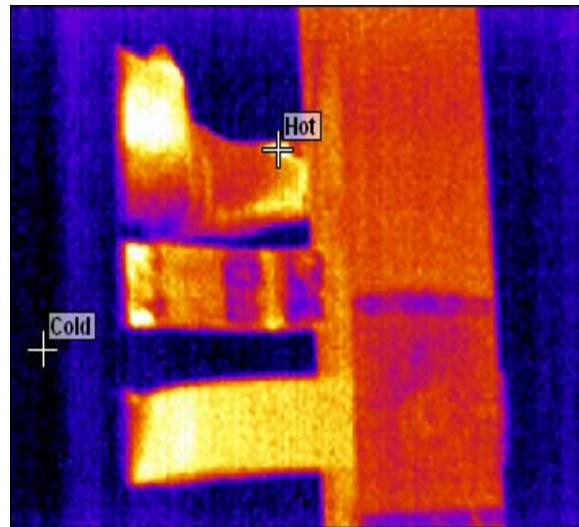
Report No. :- 01

Location	Equipment	Date	Max. Temp.	Min. Temp.	Diff. Temp.	Avg. Temp.
MAIN LT PANEL	INCOMING BUS BAR CHAMBER	30.06.08	45.4	39.8	5.6	41.6

Objective:- R ϕ BUS BAR INCOMING

Basic Observation:- R ϕ BUS BAR INCOMING is slightly heated

Analysis & Recommendation:- R ϕ BUS BAR INCOMING Temp is slightly high it can create a problem in near future so it should be needed regular monitoring.

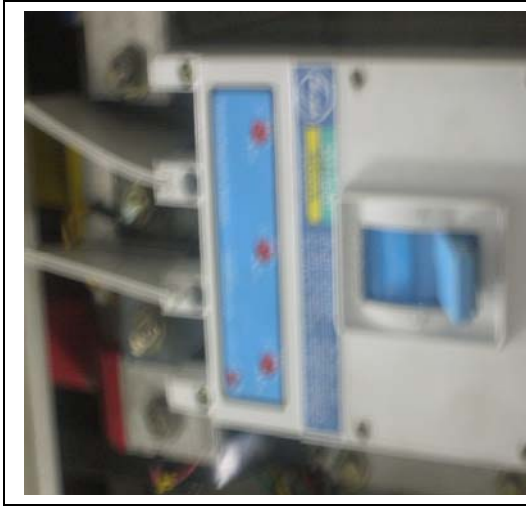
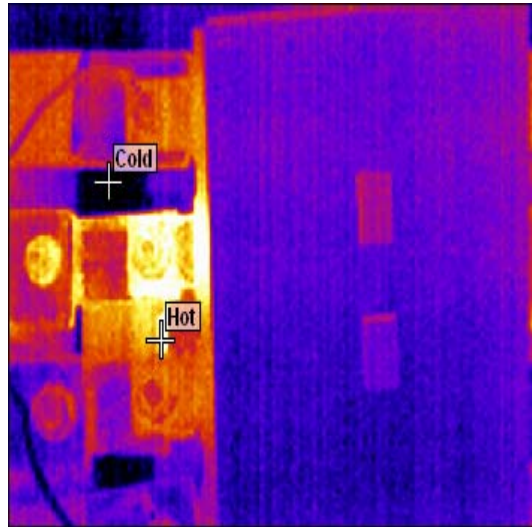
THERMOGRAPHY REPORT
Report No. :- 02

Location	Equipment	Date	Max. Temp.	Min. Temp.	Diff. Temp.	Avg. Temp.
MAIN LT PANEL	INCOMING BUS BAR CHAMBER	30.06.08	52.6	38.5	14.1	42.1

Objective:- Y Φ BUS BAR JOINT

Basic Observation:- . Y Φ BUS BAR JOINT is slightly heated

Analysis & Recommendation:- Y Φ BUS BAR JOINT Temp is slightly high it can create a problem in near future so it should be needed regular monitoring.

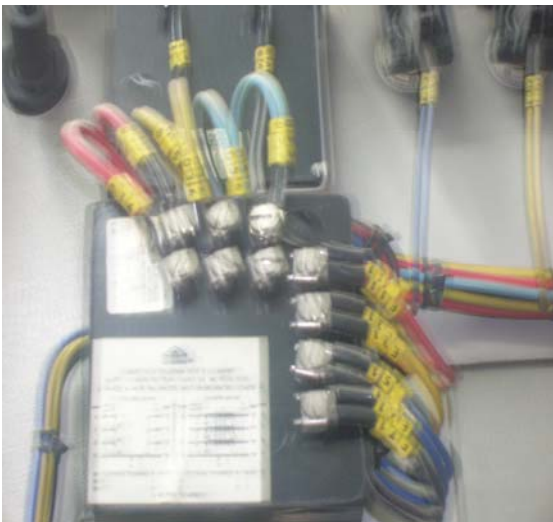
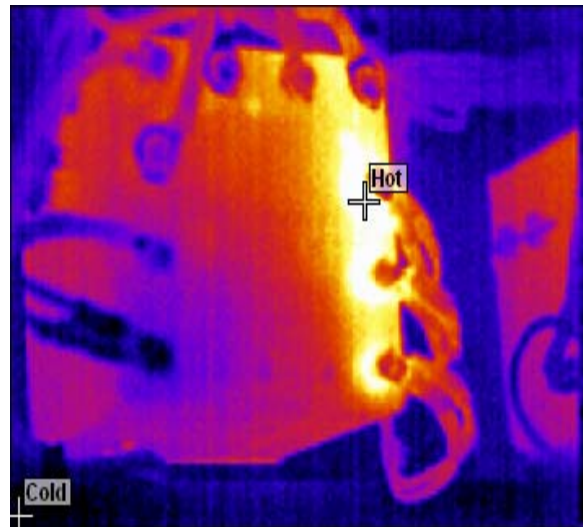
Report No. :- 03

Location	Equipment	Date	Max. Temp.	Min. Temp.	Diff. Temp.	Avg. Temp.
MAIN LT PANEL	INCOMING BUS BAR CHAMBER	30.06.08	58.8	40.3	18.5	45.6

Objective:- BOLT JOINT OF METER

Basic Observation:- . BOLT JOINT OF METER is slightly heated

Analysis & Recommendation:- BOLT JOINT OF METER Temp is slightly high it can create a problem in near future so it should be needed regular monitoring.

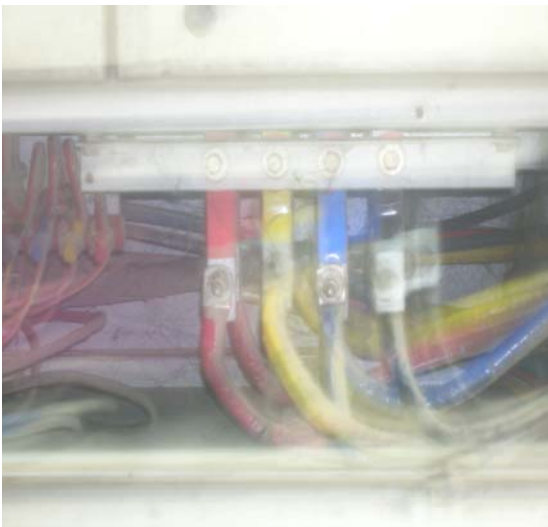
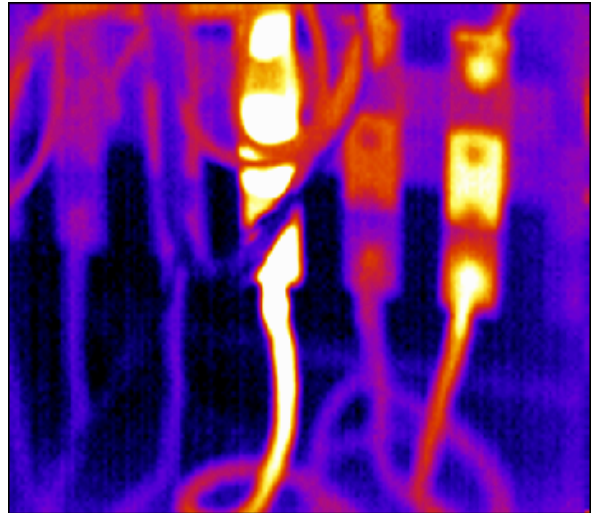
Report No. :- 04

Location	Equipment	Date	Max. Temp.	Min. Temp.	Diff. Temp.	Avg. Temp.
MAIN LT PANEL	BACK OF METERING	30.06.08	59.6	23.2	36.4	28.5

Objective:- Y Φ BOLT JOINT

Basic Observation:- . Y Φ BOLT JOINT is slightly heated

Analysis & Recommendation:- Y Φ BOLT JOINT Temp is slightly high it can create a problem in near future so it should be needed regular monitoring.

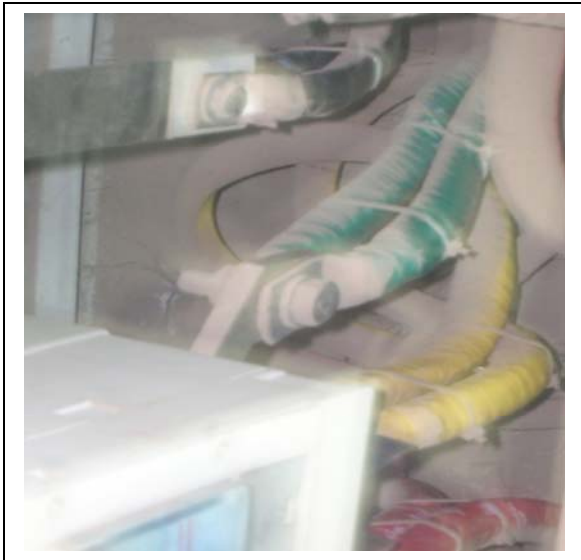
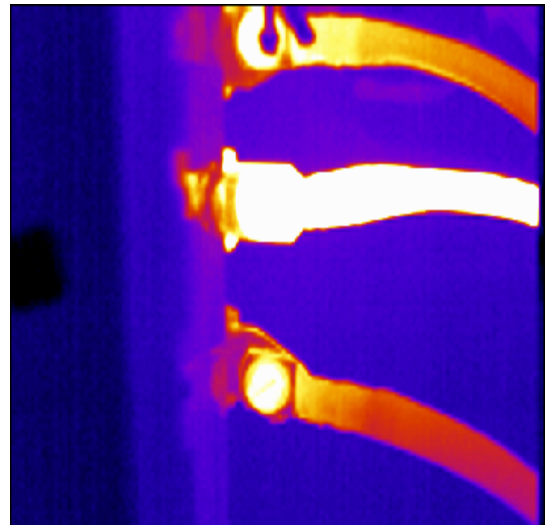
Report No. :- 05

Location	Equipment	Date	Max. Temp.	Min. Temp.	Diff. Temp.	Avg. Temp.
MAIN LT PANEL	BACK OF INCOMING BUS BAR CHAMBER	30.06.08	112.2	38.3	74.5	45.4

Objective:- SWITCH GEAR BOX

Basic Observation:- SWITCH GEAR BOX is slightly heated

Analysis & Recommendation:- SWITCH GEAR BOX Temp is slightly high it can create a problem in near future so it should be needed regular monitoring.

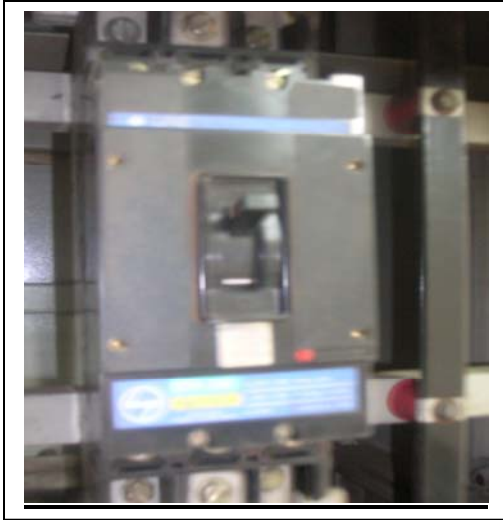
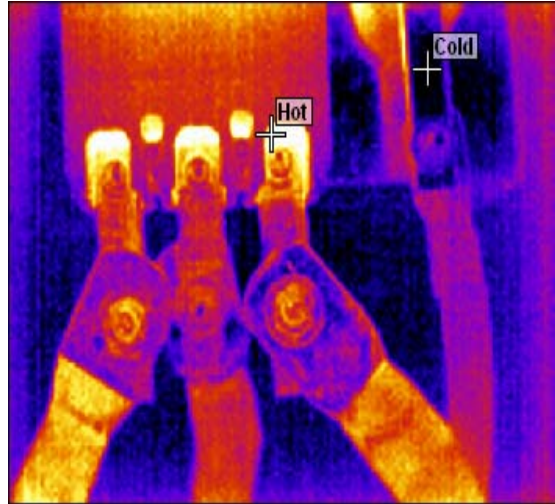
THERMOGRAPHY REPORT
Report No. :- 06

Location	Equipment	Date	Max. Temp.	Min. Temp.	Diff. Temp.	Avg. Temp.
MAIN LT PANEL	SUPPLY GOING FROM PANEL TO PLANT	30.06.08	44.9	38.6	6.3	40.8

Objective:- COMPRESSOR PANEL

Basic Observation:- . COMPRESSOR PANEL is slightly heated

Analysis & Recommendation:- COMPRESSOR PANEL Temp is slightly high it can create a problem in near future so it should be needed regular monitoring.

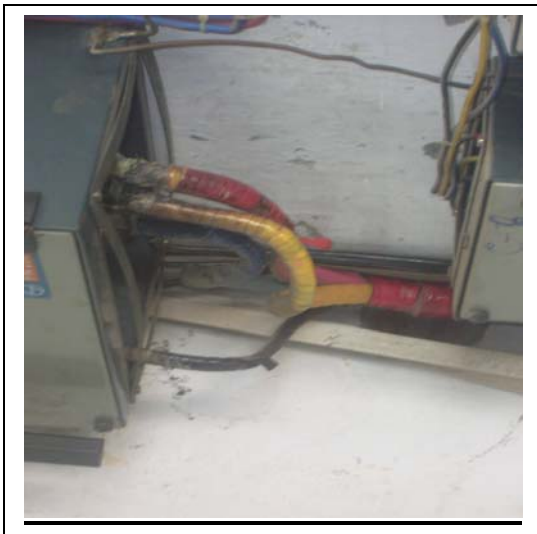
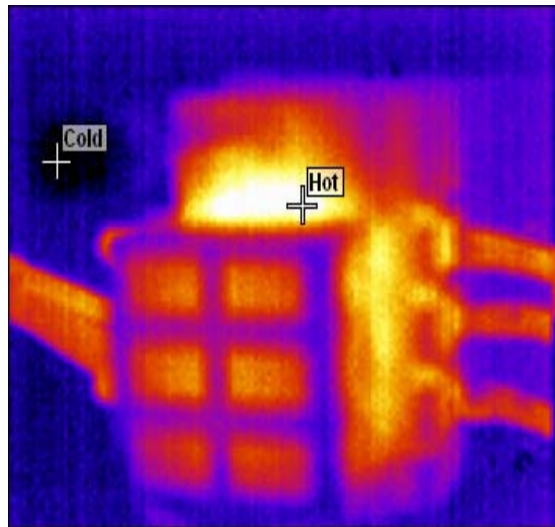
Report No. :- 07

Location	Equipment	Date	Max. Temp.	Min. Temp.	Diff. Temp.	Avg. Temp.
MAIN LT PANEL	COMPRESSOR	30.06.08	58.7	40.8	17.9	47.1

Objective:- COMPRESSOR MAIN BOX

Basic Observation:- . COMPRESSOR MAIN BOX is slightly heated

Analysis & Recommendation:- COMPRESSOR MAIN BOX Temp is slightly high it can create a problem in near future so it should be needed regular monitoring.

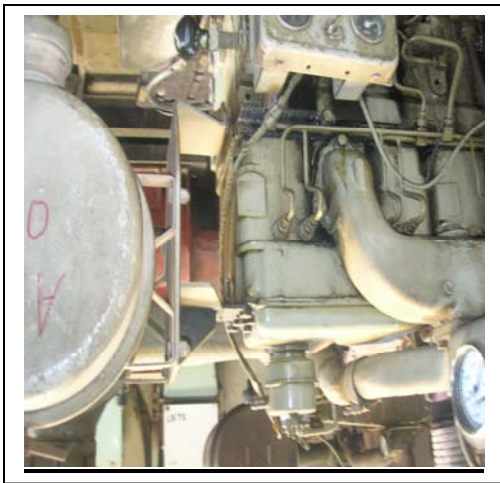
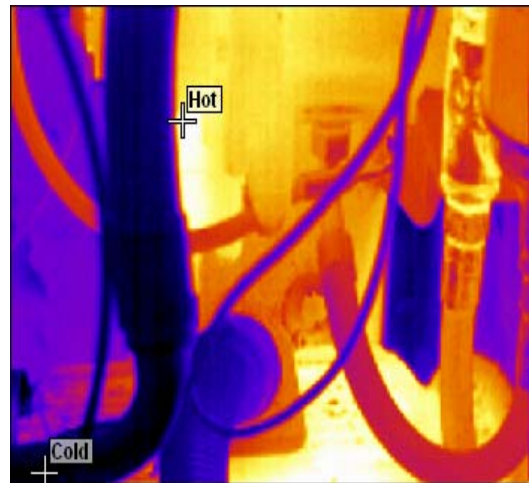
Report No. :- 08

Location	Equipment	Date	Max. Temp.	Min. Temp.	Diff. Temp.	Avg. Temp.
COMPRESOR ROOM	COMPRESSOR -1	30.06.08	86.7	54.0	32.7	68.7

Objective:- BOLT JOINT IN RELAY

Basic Observation:- . BOLT JOINT IN RELAY is over heated

Analysis & Recommendation:- BOLT JOINT IN RELAY temp. is high it's a semi critical position so close monitoring needed. Should be attended in the next opportunity.

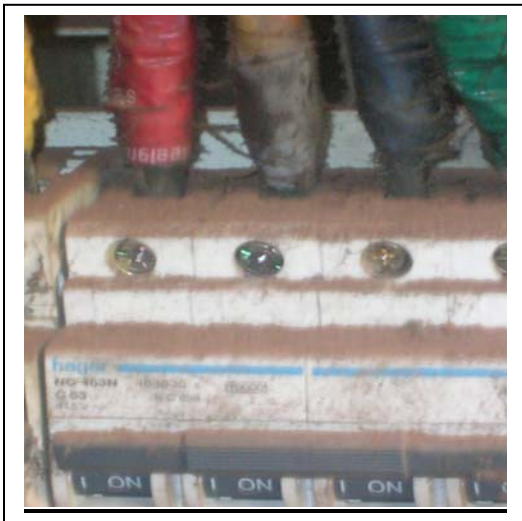
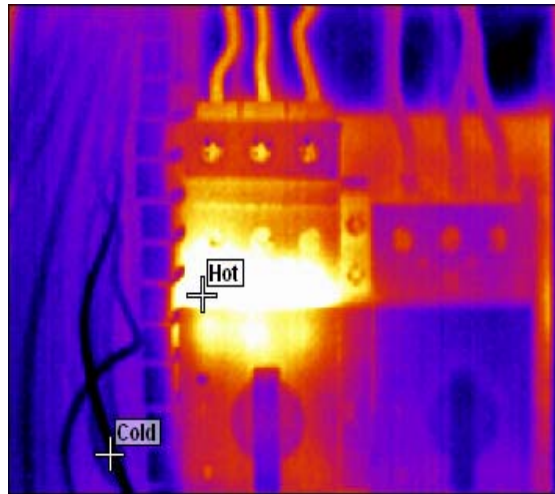
Report No. :- 09

Location	Equipment	Date	Max. Temp.	Min. Temp.	Diff. Temp.	Avg. Temp.
LABELING MACH LINE PANEL	RELAY CONTACTOR	30.06.08	78.4	43.7	34.7	50.9

Objective:- BOLT JOINT IN RELAY

Basic Observation:- . BOLT JOINT IN RELAY is over heated

Analysis & Recommendation:- BOLT JOINT IN RELAY temp. is high it's a semi critical position so close monitoring needed. Should be attended in the next opportunity.

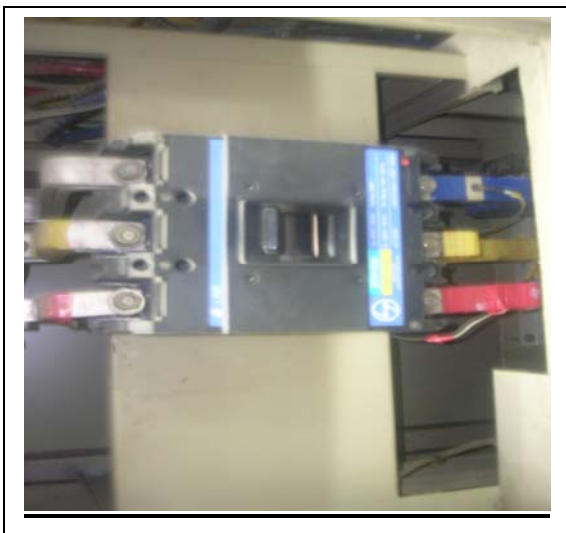
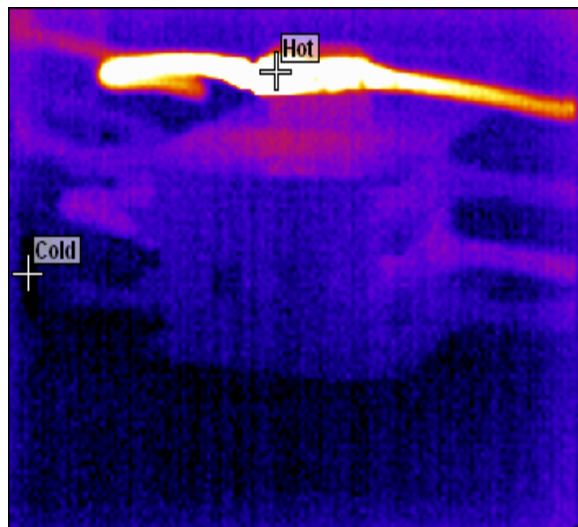
Report No. :- 10

Location	Equipment	Date	Max. Temp.	Min. Temp.	Diff. Temp.	Avg. Temp.
MAIN LT PANEL	SUPPLY FOR OFFICE AC	28.05.08	64.0	35.6	28.4	37.2

Objective:- NEUTRAL JOINT BOLT

Basic Observation:- . NEUTRAL JOINT BOLT is over heated

Analysis & Recommendation:- NEUTRAL JOINT BOLT temp. is high it's a semi critical position so close monitoring needed. Should be attended in the next opportunity.

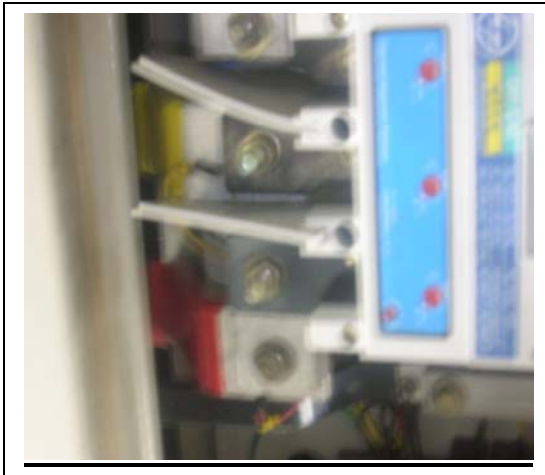
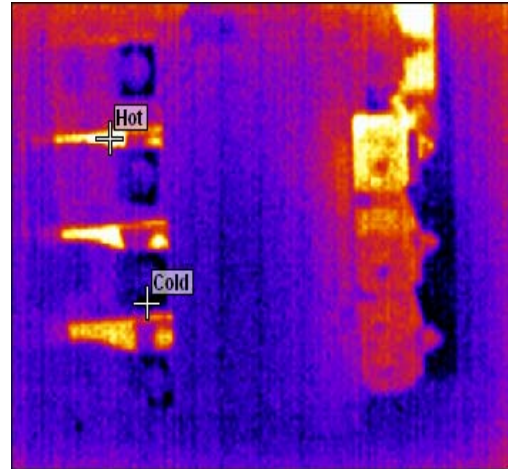
THERMOGRAPHY REPORT
Report No. :- 11

Location	Equipment	Date	Max. Temp.	Min. Temp.	Diff. Temp.	Avg. Temp.
MAIN LT PANEL	AC MAIN	30.06.08	43.1	36.2	6.9	37.9

Objective:- INCOMING DVB

Basic Observation:- . INCOMING DVB is slightly heated

Analysis & Recommendation:- INCOMING DVB Temp is slightly high it can create a problem in near future so it should be needed regular monitoring.

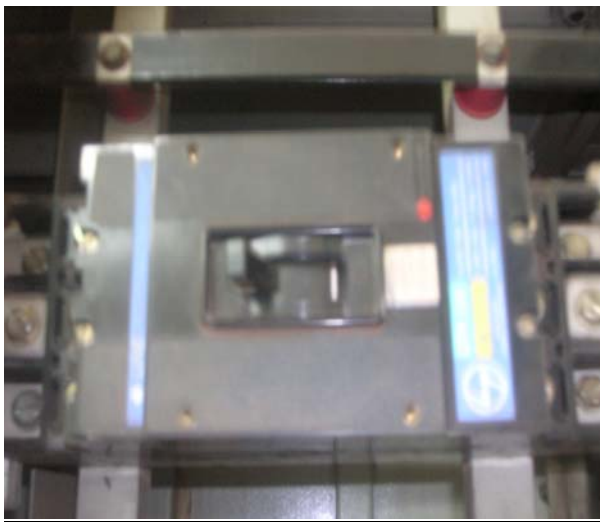
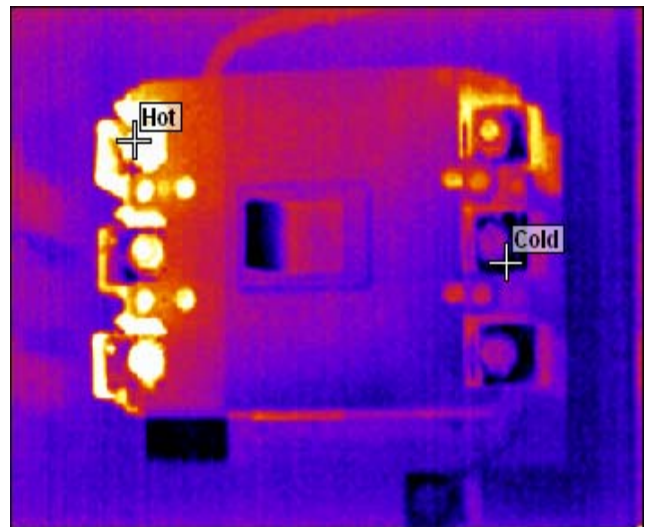
Report No. :- 12

Location	Equipment	Date	Max. Temp.	Min. Temp.	Diff. Temp.	Avg. Temp.
MAIN LT PANEL	MAIN SUPPLY LINE	30.06.08	54.5	37.5	17.0	40.7

Objective:- INCOMING TO PANEL

Basic Observation:- . INCOMING TO PANEL is slightly heated

Analysis & Recommendation:- INCOMING TO PANEL Temp is slightly high it can create a problem in near future so it should be needed regular monitoring.

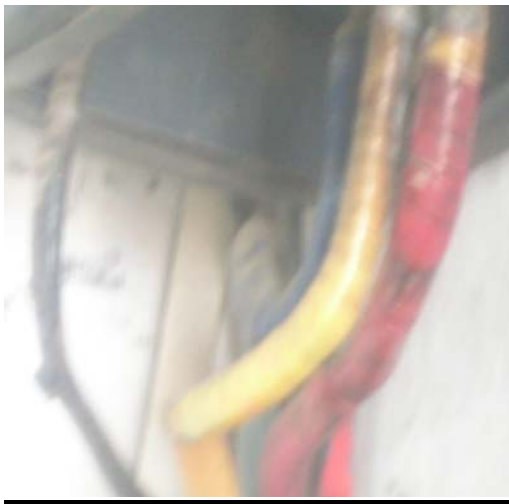
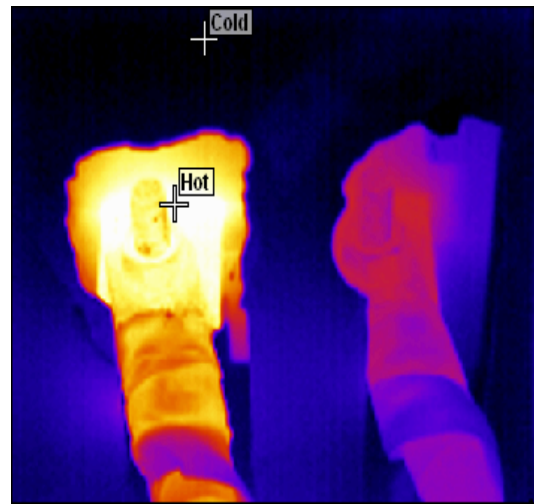
Report No. :- 13

Location	Equipment	Date	Max. Temp.	Min. Temp.	Diff. Temp.	Avg. Temp.
MAIN LT PANEL	MAIN SWITCH	30.06.08	75.8	40.2	35.6	48.2

Objective:- Y Φ LUG JOINT

Basic Observation:- . Y Φ LUG JOINT is over heated

Analysis & Recommendation:- Y Φ LUG JOINT temp. is high it's a semi critical position so close monitoring needed. Should be attended in the next opportunity.

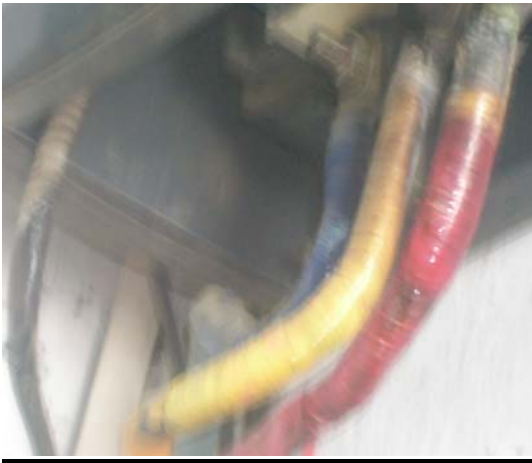
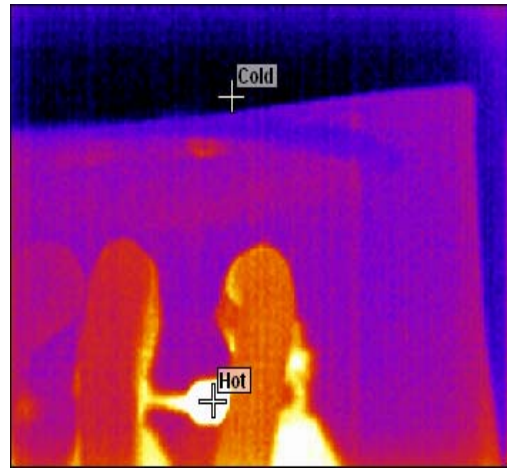
THERMOGRAPHY REPORT
Report No. :- 14

Location	Equipment	Date	Max. Temp.	Min. Temp.	Diff. Temp.	Avg. Temp.
MAIN LT PANEL	POWER FACTOR	30.06.08	89.6	35.4	54.2	38.6

Objective:- **R Φ LUG JOINT**

Basic Observation:- **R Φ LUG JOINT** is over heated.

Analysis & Recommendation:- **R Φ LUG JOINT** temp. is very high it should be attended immediately as per the severity.

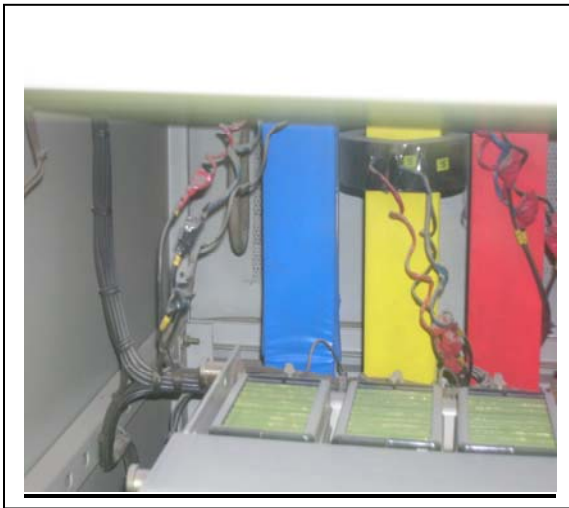
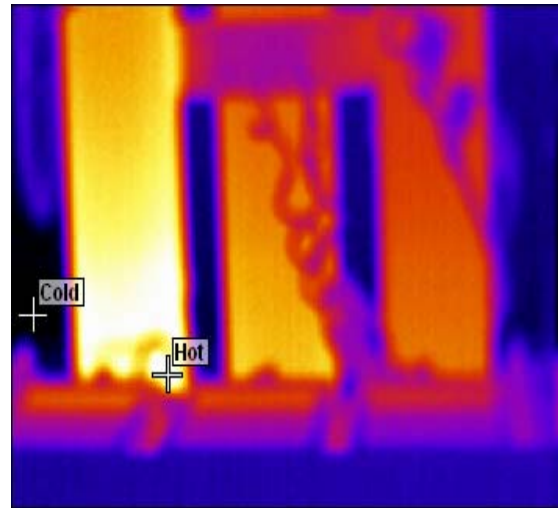
THERMOGRAPHY REPORT
Report No. :- 15

Location	Equipment	Date	Max. Temp.	Min. Temp.	Diff. Temp.	Avg. Temp.
MAIN LT PANEL J I & 2	1F2 (MAIN UPSEB INCOMER)	01.07.08	69.9	31.5	38.4	47.0

Objective:- B Φ BUS BAR

Basic Observation:- . B Φ BUS BAR is over heated

Analysis & Recommendation:- B Φ BUS BAR temp. is high it's a semi critical position so close monitoring needed. Should be attended in the next opportunity.

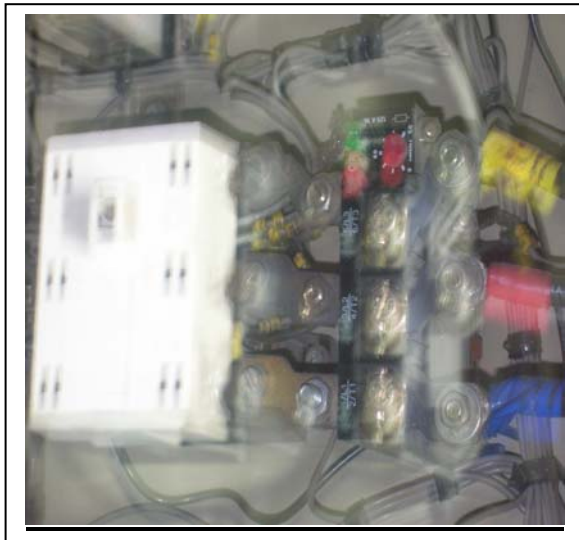
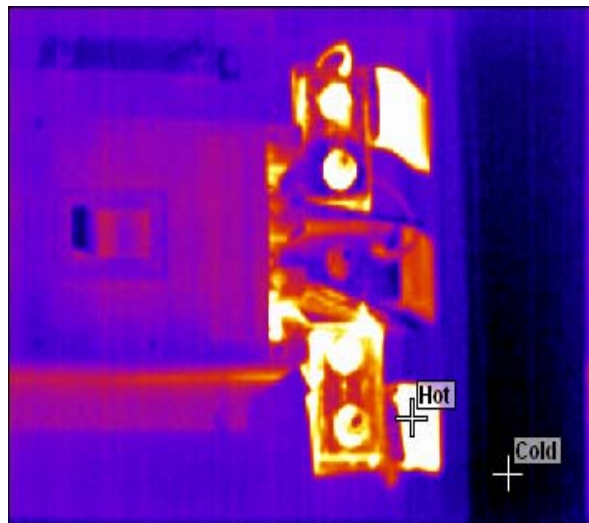
Report No. :- 16

Location	Equipment	Date	Max. Temp.	Min. Temp.	Diff. Temp.	Avg. Temp.
LT PANEL EMERGENCY	1F1 (METERING FOR INCOMER)	01.07.08	68.2	31.9	36.3	38.5

Objective:- R Φ BUS BAR LUG JOINT

Basic Observation:- . R Φ BUS BAR LUG JOINT is over heated

Analysis & Recommendation:- R Φ BUS BAR LUG JOINT temp. is high it's a semi critical position so close monitoring needed. Should be attended in the next opportunity.

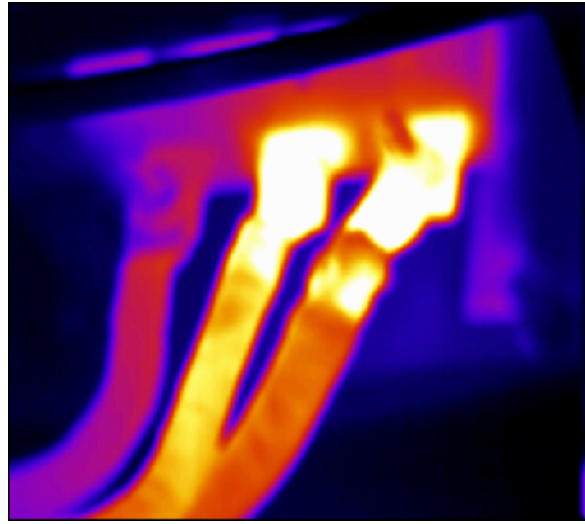
THERMOGRAPHY REPORT
Report No. :- 17

Location	Equipment	Date	Max. Temp.	Min. Temp.	Diff. Temp.	Avg. Temp.
CAPACITOR ROOM	MAIN 110 KVAR	28.05.08		45.7	106.4	69.7

Objective:- Y Φ LUG JOINT

Basic Observation:- . Y Φ LUG JOINT is over heated

Analysis & Recommendation:- Y Φ LUG JOINT temp. is very high it should be attended immediately as per the severity.

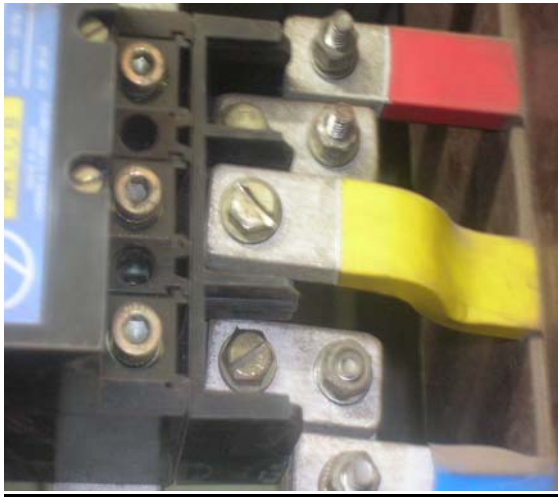
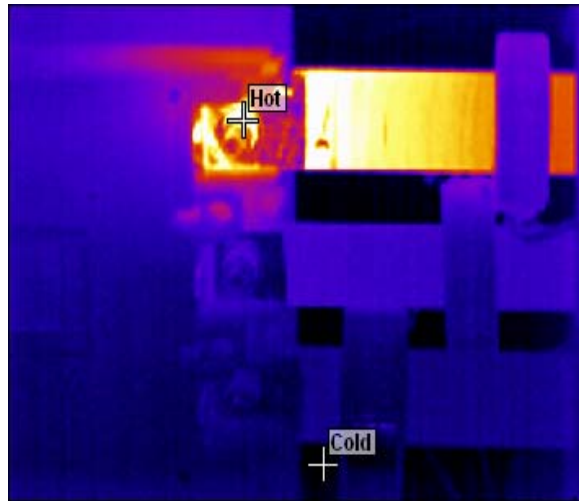
Report No. :- 18

Location	Equipment	Date	Max. Temp.	Min. Temp.	Diff. Temp.	Avg. Temp.
AC PLANT	AC PLANT INCOMING	01.07.08	69.4	38.5	30.9	43.8

Objective:- R Φ BOLT JOINT

Basic Observation:- . R Φ BOLT JOINT is over heated

Analysis & Recommendation:- R Φ BOLT JOINT temp. is high it's a semi critical position so close monitoring needed. Should be attended in the next opportunity.

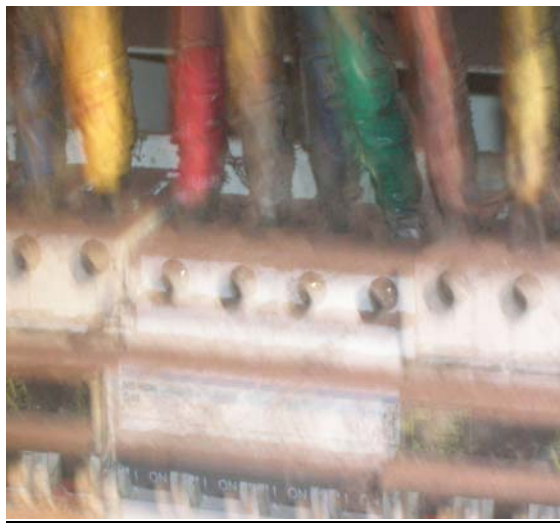
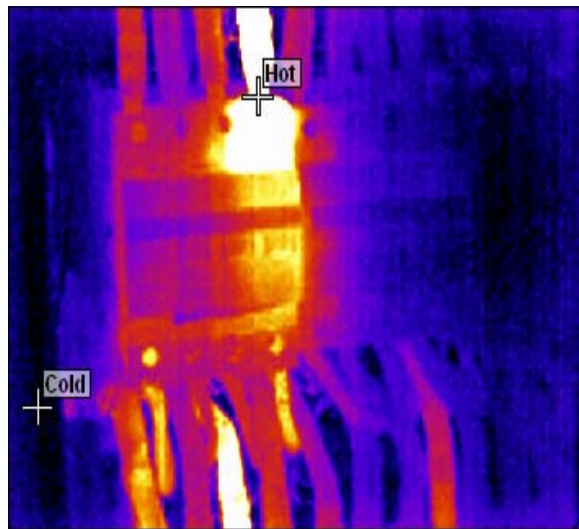
THERMOGRAPHY REPORT
Report No. :- 19

Location	Equipment	Date	Max. Temp.	Min. Temp.	Diff. Temp.	Avg. Temp.
OUTSIDE ROOM	MAIN D.B. LINE	01.07.08	67.0	38.9	28.1	41.6

Objective:- MCB R ϕ JOINT

Basic Observation:- . MCB R ϕ JOINT is over heated

Analysis & Recommendation:- MCB R ϕ JOINT temp. is high it's a semi critical position so close monitoring needed. Should be attended in the next opportunity.

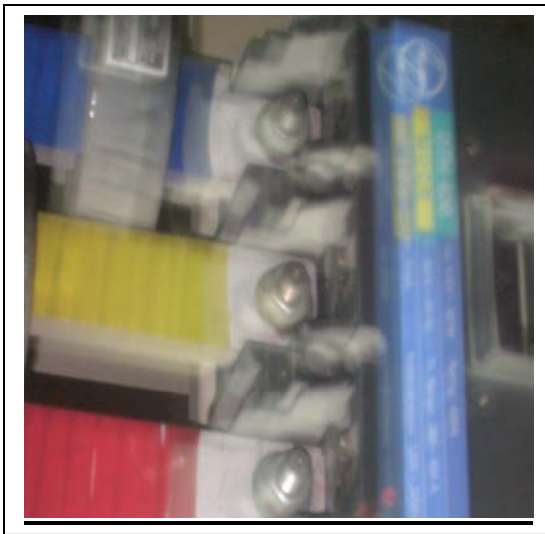
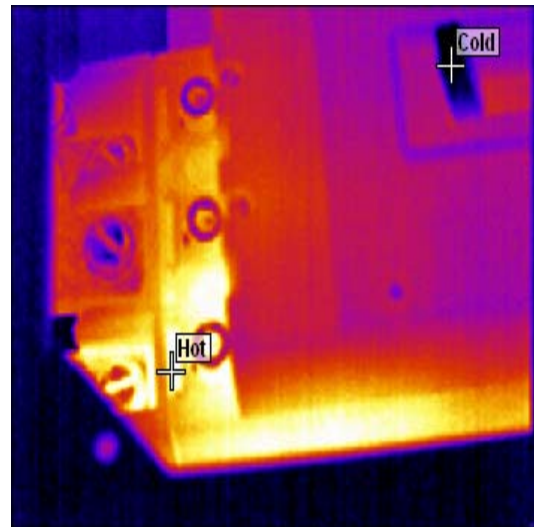
THERMOGRAPHY REPORT
Report No. :- 20

Location	Equipment	Date	Max. Temp.	Min. Temp.	Diff. Temp.	Avg. Temp.
OUT SIDE ROOM(OFFICE LIGHTING)	MAIN D.B. LINE	01.07.08	66.2	44.7	21.5	53.0

Objective:- BOLT JOINT INCOMING BUS BAR

Basic Observation:- . BOLT JOINT INCOMING BUS BAR is over heated

Analysis & Recommendation:- BOLT JOINT INCOMING BUS BAR temp. is high it's a semi critical position so close monitoring needed. Should be attended in the next opportunity.
